Inspector: Mark H. Evans
Client: XXXXX XXXXXX

The following is a report of the inspection conducted on XXXXX, for the property at. The temperature was 68 degrees and the weather was dry. The client and seller were present during the inspection. The home is two years old and was occupied. Many areas of the house could not be seen to inspect. There is a full basement under the house and crawlspace under the deck/porch that wraps around the house. The main attic was entered. The air handlers are located in the main attic. The tankless water heater is located on the right side of the exterior wall. The water pipes are plastic PEX, the drain pipes are PVC and the wiring throughout the house is nonmetallic cable. The kitchen appliances and bathroom fixtures are serviceable except as noted below. The exterior siding is fibrous cement, stone veneer, wood and vinyl. The interior floors, ceilings, staircases, doors and walls are serviceable except as noted below. The fireplaces, whole house generator, well, detached buildings, propane gas heater, jetted bathtub and fences were not inspected. Contact a licensed chimney sweep prior to using the fireplaces. The fireplaces do not appear to have

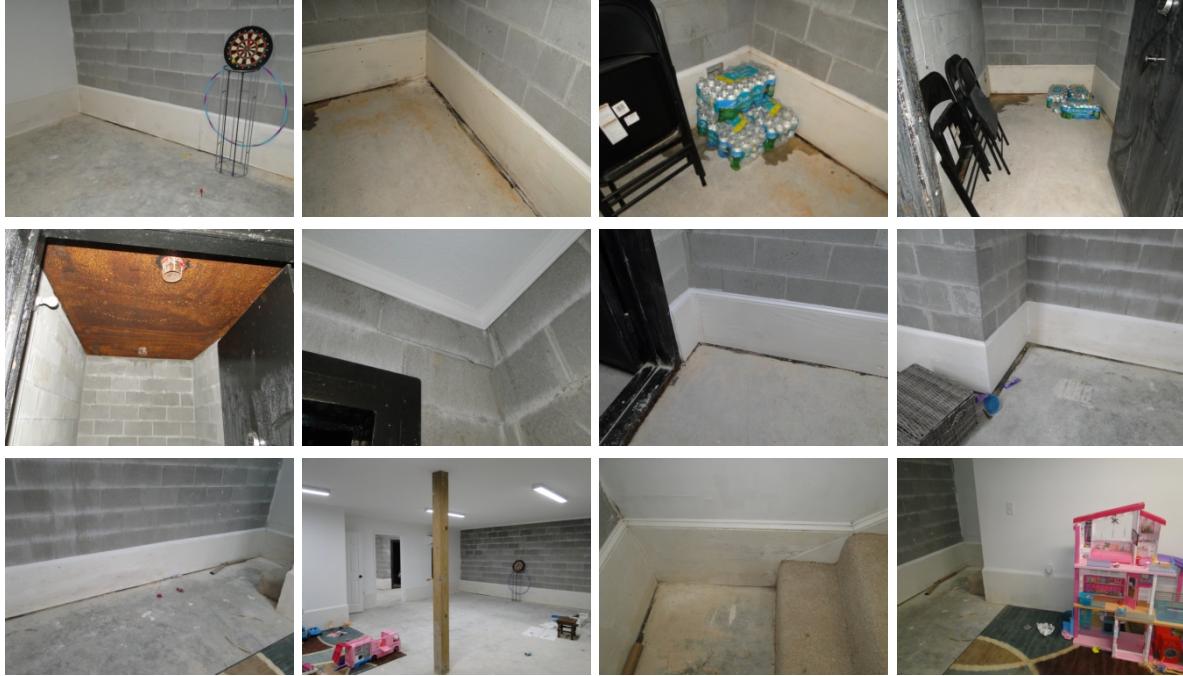
1). The bottoms of the exterior walls in the basement are wet and damp in many areas. The wood covering the bottoms of the walls are moisture stained in most areas. The safe room is corroded in most areas. The bottom of the safe room's door frame is rusted. Unable to verify if the walls had been recently painted. Air fresheners were being used to cover the musty odors. FYI A second means of egress is required if the basement is ever used as a habitable space.

Contact fully qualified licensed contractors for repairs.

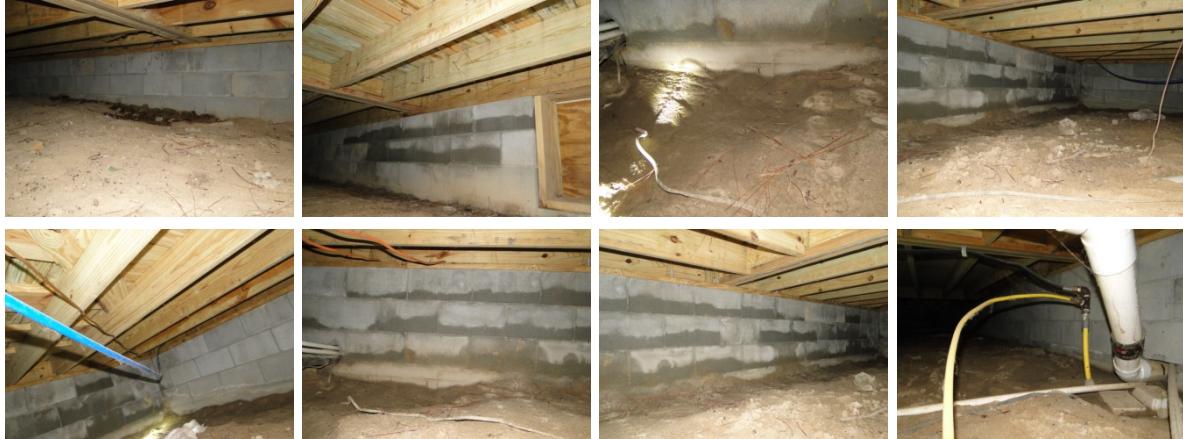
2). The ground is wet under the rear deck behind the heat pumps. The ground is damp in a few areas. The back side of the outside foundation wall behind the stone veneer is damp in many areas. Recommend installing gutters around the perimeter of the roof.

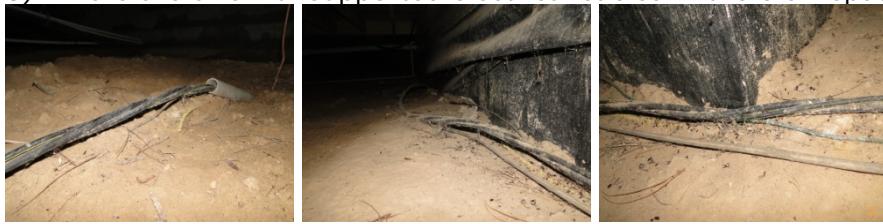
3). There are a few unsupported electrical cables in the crawlspace. Many are on the ground.

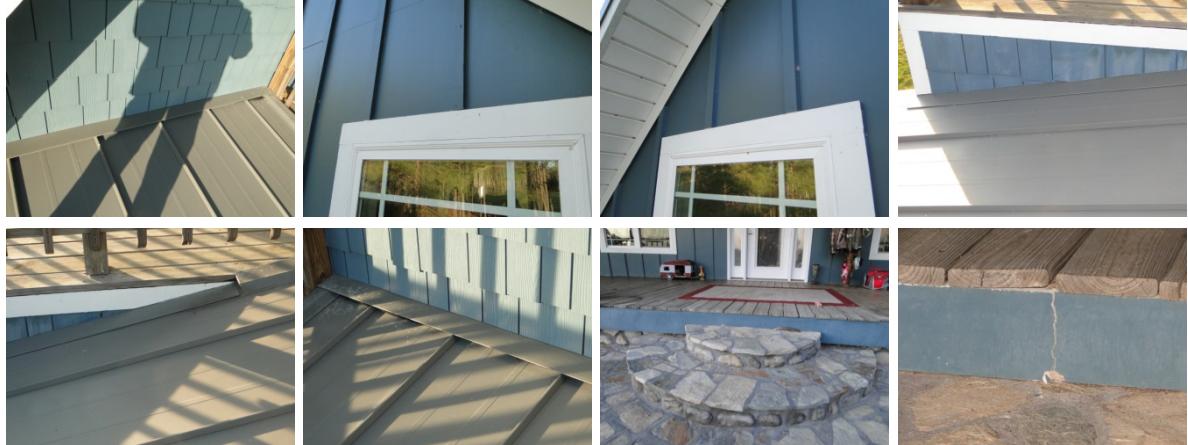
1). The fibrous siding and trim are improperly installed in a few areas. Flashings are missing above the top of all windows. The siding is touching hardscape and flashings in many areas. The siding along the front deck/porch is damaged in a few areas above the steps.

Contact a fully qualified licensed contractor for repairs.

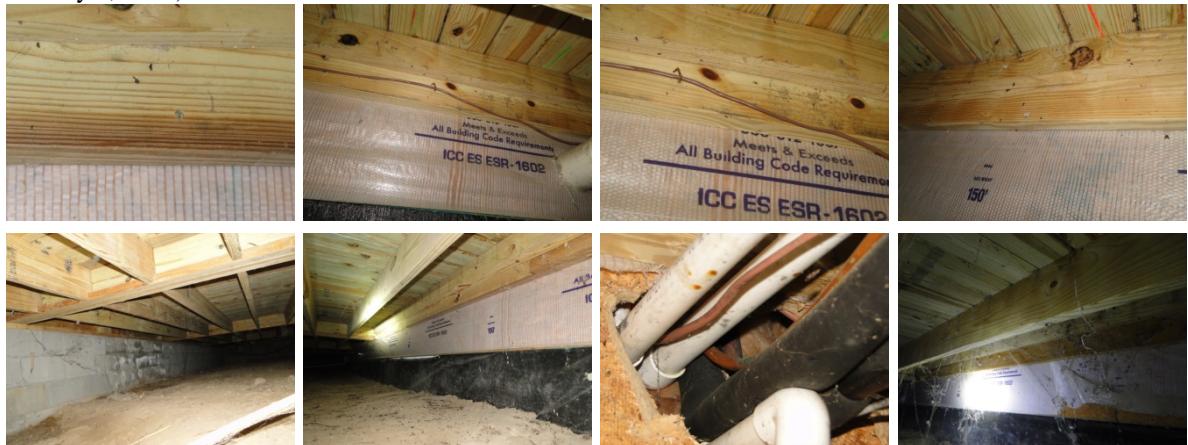
2). The wrap around deck/porch is secured to the house with nails instead of lag screws. Flashings are missing along the transition between the deck and exterior walls. The exposed walls under the deck in the crawlspace are unfinished. The exposed oriented strand board (OSB) wall sheathing is only covered a moisture resistant barrier. **2014 IRC R507.1 Decks.** Decks shall be constructed in accordance with this code or the Prescriptive Deck Details design document, which is available to download free from DCA's webpage located at:

Where supported by attachment to an exterior wall, decks shall be positively anchored to the primary structure and designed for both vertical and lateral loads. Such attachment shall not be accomplished by the use of toenails or nails subject to withdrawal. Where positive connection to the primary building structure cannot be verified during inspection, decks shall be self-supporting. For decks with cantilevered framing members, connections to exterior walls or other framing members, shall be designed and constructed to resist uplift resulting from the full live load specified in Table R301.5 acting on the cantilevered portion of the deck. Deck ledger and band joist connections shall be through bolted. The placement of lag screws and other fasteners in deck ledgers and band joist connections shall be prohibited. (Effective January 1, 2014)

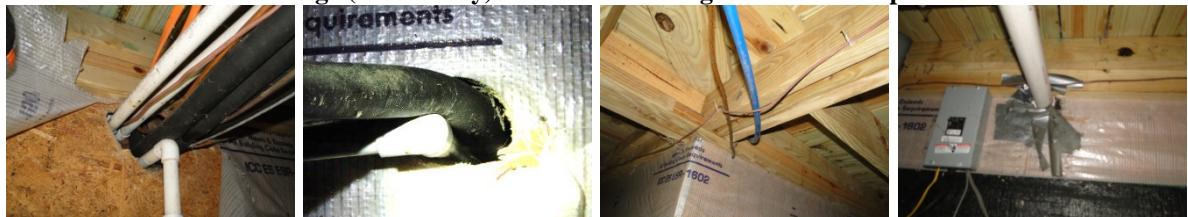
3). The cable and pipe penetrations to the exterior siding and the foundation walls are unsealed. **2009 IECC 402.4 Air leakage (Mandatory) & 402.4.1 Building thermal envelope.**

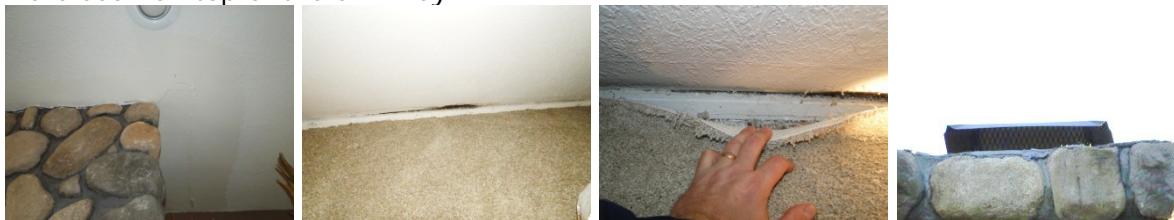
2). There are a few areas of prior leaks under the living room chimney. The living room ceiling is moisture damaged around the fireplace. The master bedroom closet has a mold like fungal growth on the wall/floor above the front of the chimney. The seller indicated the leak was repaired by the builder. The chimney and fireplace were not inspected. A cap and spark screen were seen on top of the chimney.

Contact a fully qualified licensed roofing contractor for repairs. The roof above the wrap around porch/deck was walked on. The roof above the second floor was observed from the roof on the wrap around porch/deck and ground.

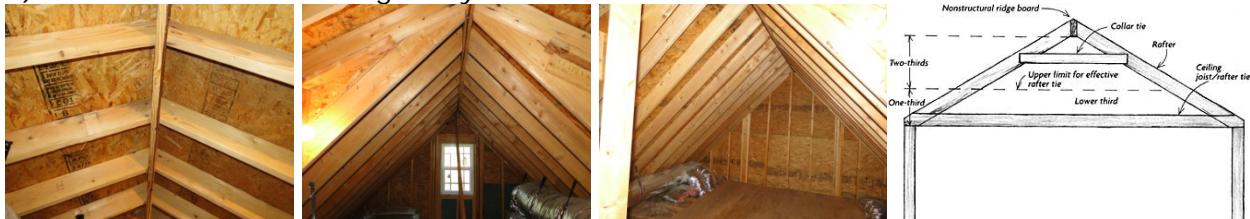
3). Collar beams are missing every four feet between the rafters.

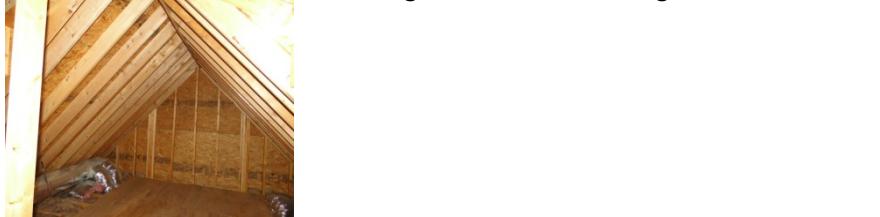
4). A diagonal brace is missing behind the front gable wall above the master bedroom.

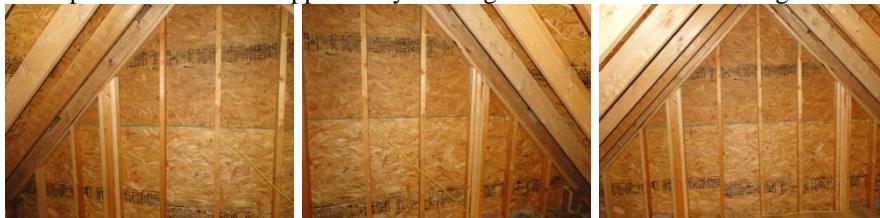
5). Blocking is missing between the horizontal seams on the gable walls' sheathing. **2012 IRC Note i, Table 602.3 (1)**. i. Spacing of fasteners on floor sheathing panel edges applies to panel edges supported by framing members and required blocking and at all floor perimeters only. Spacing of fasteners on roof sheathing panel edges applies to panel edges supported by framing members and required blocking. Blocking of roof or floor sheathing panel edges perpendicular to the framing members need not be provided except as required by other provisions of this code. Floor perimeter shall be supported by framing members or solid blocking.

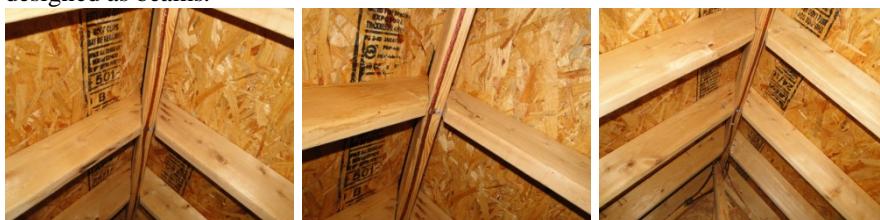
6). The main ridge board is less in depth than the cut end of many of the rafters. **2012 IRC R802.3 Framing details**. Rafters shall be framed to ridge board or to each other with a gusset plate as a tie. Ridge board shall be at least 1-inch (25 mm) nominal thickness and not less in depth than the cut end of the rafter. At all valleys and hips there shall be a valley or hip rafter not less than 2-inch (51 mm) nominal thickness and not less in depth than the cut end of the rafter. Hip and valley rafters shall be supported at the ridge by a brace to a bearing partition or be designed to carry and distribute the specific load at that point. Where the roof pitch is less than three units vertical in 12 units horizontal (25-percent slope), structural members that support rafters and ceiling joists, such as ridge beams, hips and valleys, shall be designed as beams.

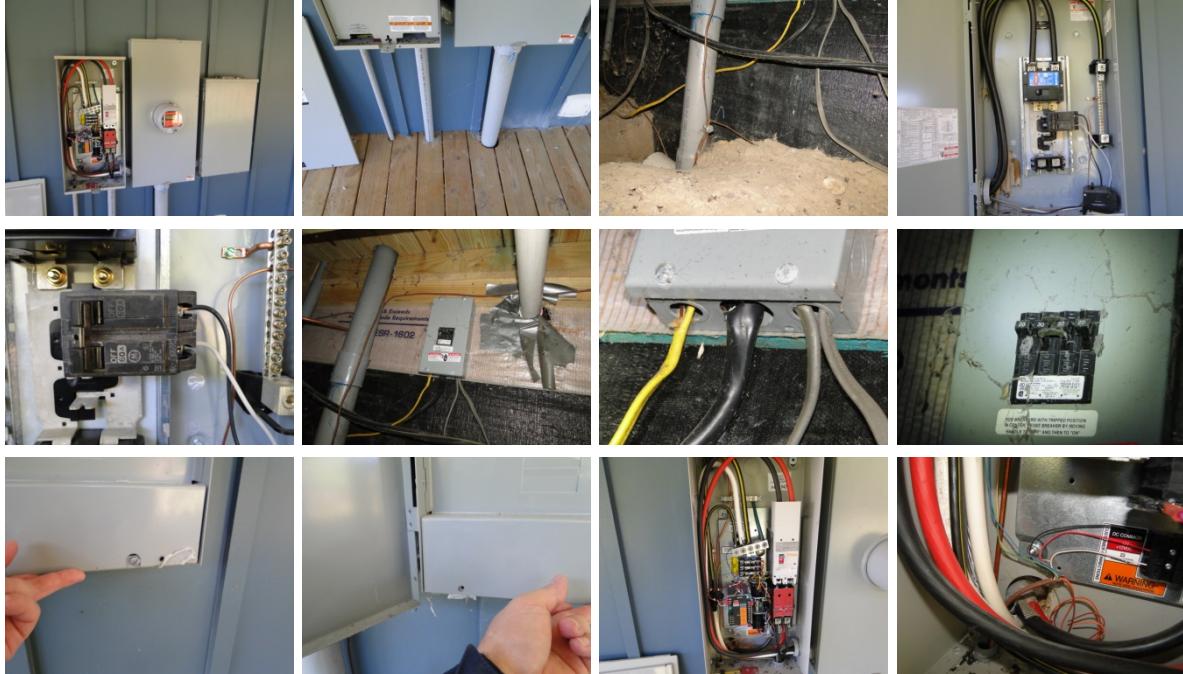
1). The conduit under the utility meter is not secured to the exterior wall. The 60amp GE circuit breaker inside the right side service panel is not listed to be used inside the Eaton Panel. The 12 gauge 20amp conductor entering the 60amp circuit breaker is overfused. The 60amp circuit breaker is not identified. The screws are missing to both of the service panels dead front covers. The service entrance cable entering the exterior wall inside the service panel is unsecured.

Contact a fully qualified licensed electrical contractor for repairs.

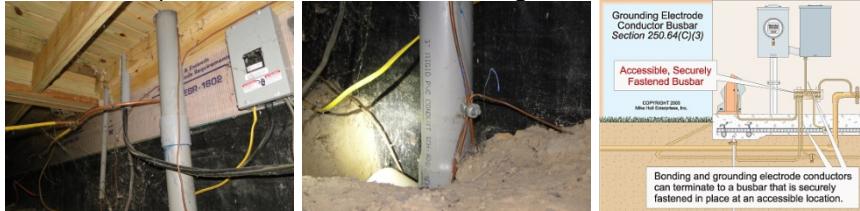
2). An intersystems bonding terminal is missing on the grounding electrode conductor under the utility meter. The panel under the deck/porch next to the grounding electrode conductor is not readily accessible. The circuit breakers are uncovered and are not identified. The small panel was not inspected. The cables entering the bottom of the panel are missing clamps or bushings.

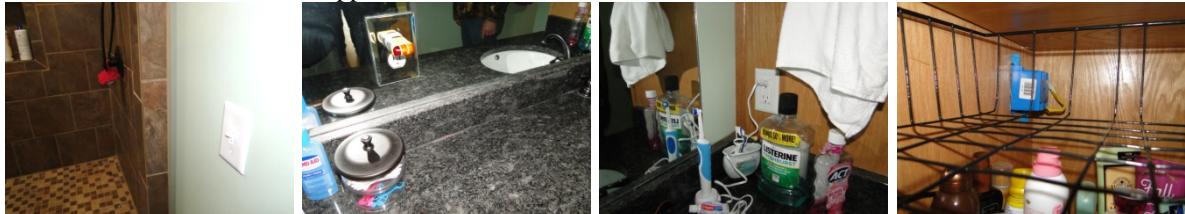
6). The master shower light fixture's light switch is in reach of the shower. Recommend adding ground fault protection to the light circuit. The master bathroom receptacle on the wall next to the left side of the sink is missing ground fault protection. The non-metallic cable inside the master bathroom cabinet next to the sink is not protected from physical damage. **2014 NEC 334.15 Exposed Work.** In exposed work, except as provided in 300.11(A), cable shall be installed as specified in 334.15(A) through (C). **(B) Protection from Physical Damage.** Cable shall be protected from physical damage where necessary by rigid metal conduit, intermediate metal conduit, electrical metallic tubing, Schedule 80 PVC conduit, Type RTRC marked with the suffix -XW, or other approved means.

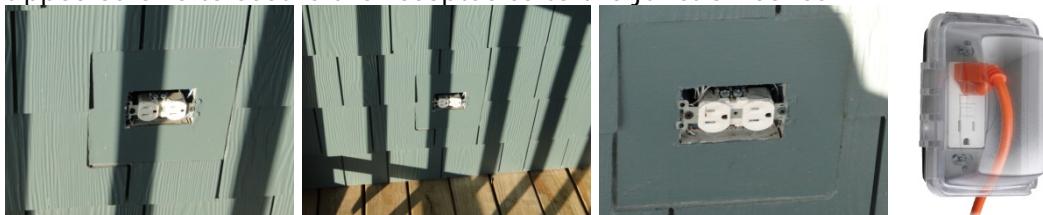
7). Cover plates (in-used types) are missing on the master bedroom's exterior receptacles on both sides of the French doors. FYI Sheetrock screws (pointed) are being used in place of blunt tipped screws to secure the receptacles to the junction boxes.

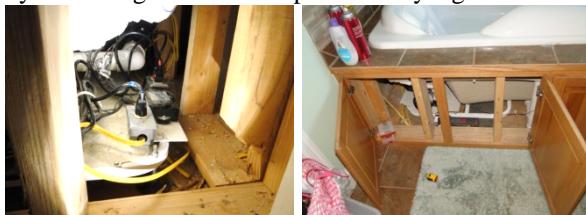
8). The jetted bathtub circuit is missing ground fault protection. The receptacles are installed inside the enclosure instead in an accessible location. **2014 NEC 680.73 Accessibility.** Hydromassage bathtub electrical equipment shall be accessible without damaging the building structure or building finish. Where the hydromassage bathtub is cord- and plug-connected with the supply receptacle accessible only through a service access opening, the receptacle shall be installed so that its face is within direct view and not more than 300 mm (1 ft) of the opening. **680.71 Protection.** Hydromassage bathtubs and their associated electrical components shall be on an individual branch circuit(s) and protected by a readily accessible ground-fault circuit interrupter. All 125-volt, single-phase receptacles not exceeding 30 amperes and located within 1.83 m (6 ft) measured horizontally of the inside walls of a hydromassage tub shall be protected by a ground-fault circuit interrupter.

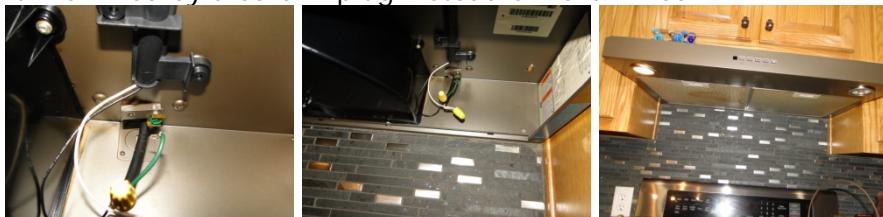
10). The range exhaust fan is not functional. The fan motor is defective. The wire connections are exposed inside the range fan hood above the filters. The fan motor is ungrounded. FYI The fan is wired by a cord-n-plug instead of hard-wired.

The range ventilation hood is non-functional. The right side light bulb is blown. See electrical #10.

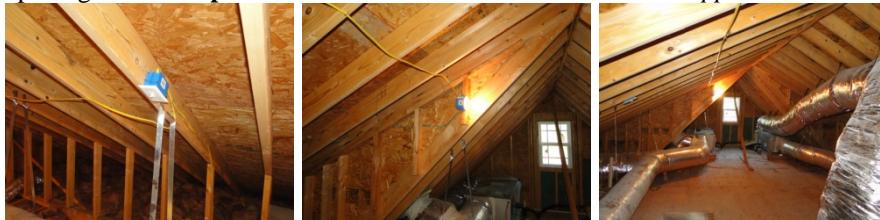
11). An arc fault protected duplex receptacle is missing in the attic near the air handlers.

2012 IRC M1305.1.3.1 Electrical requirements. A luminaire controlled by a switch located at the required passageway opening and **a receptacle outlet** shall be installed at or near the *appliance* location in accordance with Chapter 39.

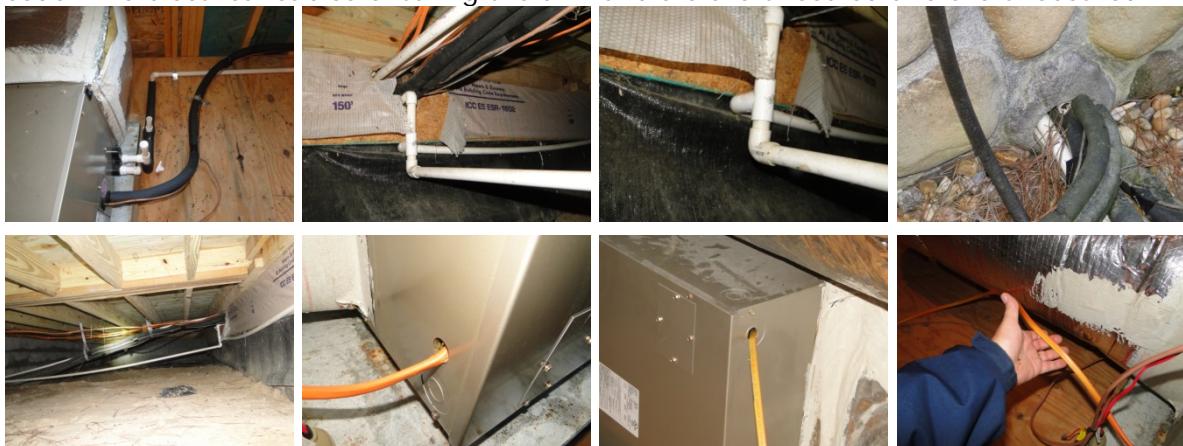
1). The air handler's primary condensation drain pipes are connected together in the crawlspace. The drain pipes are not fully supported or insulated. One of the drain pipes terminates flush with the foundation wall. The air handlers' 30amp circuit breakers inside the main panel appear to be undersized. The actual size of the disconnects are not identified on the cabinets as required by code. The electrical cables entering the air handlers are unsealed and are unsecured.

Contact a fully qualified licensed HVAC contractor for further evaluation, repairs as needed and to verify that the heat pumps' disconnects are not oversized and the air handlers' circuit breakers are not undersized. The first and second floor split system heat pumps and air handlers were tested in the cooling mode and were serviceable.

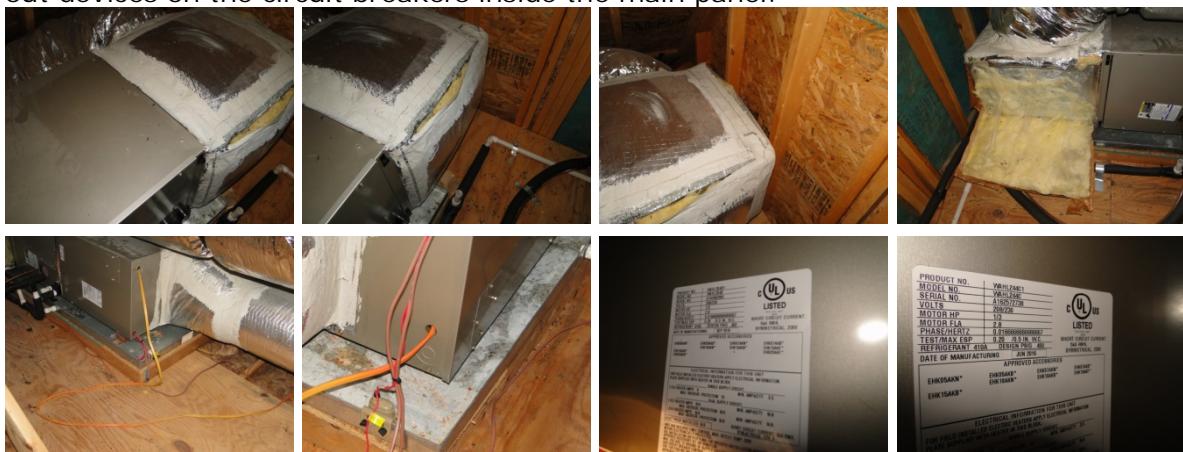
2). The plenums attached to the air handlers are coming apart in a few areas. The evaporator coil inside the 2 tons air handler needs cleaned. The 2 ton (upstairs) air handler's overflow catch pan is covered in water marks. Electrical disconnects are missing near the air handler's or lock-out devices on the circuit breakers inside the main panel.

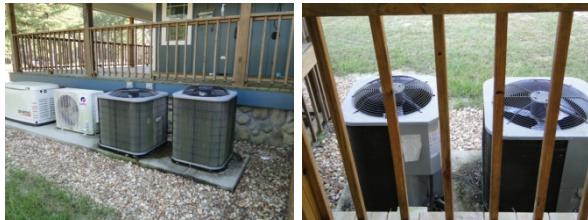
3). The 2 & 2 ½ ton heat pumps are installed too close together for proper airflow. The manufacturer's installation instructions indicates the space between heat pumps' must be no less than 24 inches.

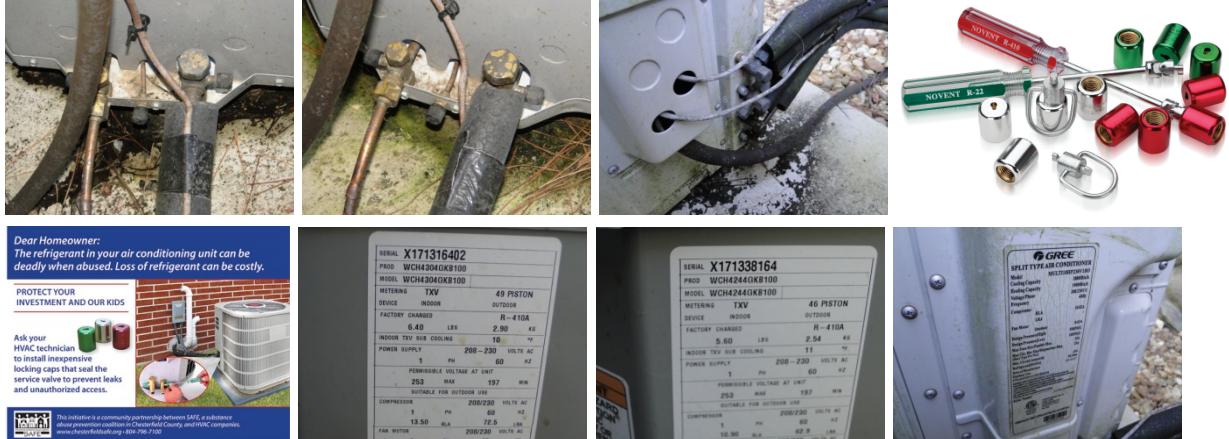
4). Locking access caps are missing on all of the refrigerant pipe fittings on all three of the heat pumps. The caps prevent children from "huffing" the refrigerant. **2012 IRC M1411.6 Locking access port caps.** Refrigerant circuit access ports located outdoors shall be fitted with locking-type tamper-resistant caps or shall be otherwise secured to prevent unauthorized access. *Some people have addictions to chemicals. Some people have the desire to alter their individual state and this is sometimes called self-medicating. One of the phenomena happening in this world of drug abuse is the "huffing" of refrigerant. People are inhaling refrigerants and getting high from the oxygen deprivation. The refrigerant is heavier than oxygen and therefore, the huffing becomes dangerous because the individual is unable to replace the heavy chemical with fresh air. An organization called United Parents to Restrict Open Access to Refrigerant (UPROAR) was created when a teenager died as result of refrigerant huffing. The neurotoxic chemicals in inhalants in general can cause chemical dependency and mental illness. The International Mechanical Code (section 1101.10) and the International Residential Code (section M1411.6) are now requiring the use of locking caps. Section M1411.6 says, "Locking access port caps. Refrigerant circuit access ports located outdoors shall be fitted with locking-type tamper-resistant caps." These caps are lockable and can only be accessed by a licensed HVAC professional who is equipped with a special tool. The caps may be color coded to allow for easy recognition of certain refrigerant lines.*

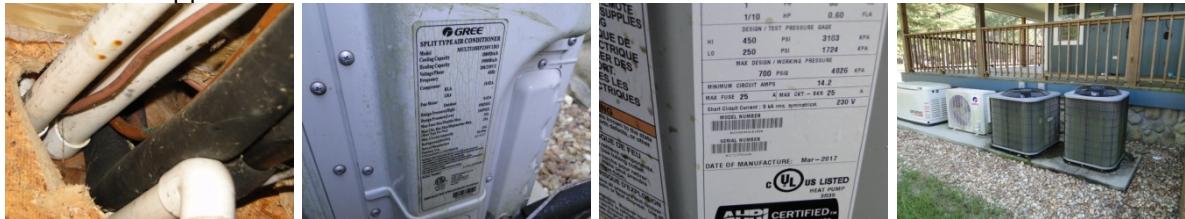
5). The 1 ½ ton mini-split system heat pump was not inspected. The indoor units were operational in the basement during the beginning of the inspection. The condensation drain pipes that were visible coming out of the rear foundation wall are not insulated. The walls under the inside units are moisture stained in a few areas from condensation. FYI The heat pump's disconnect appears to be oversized.

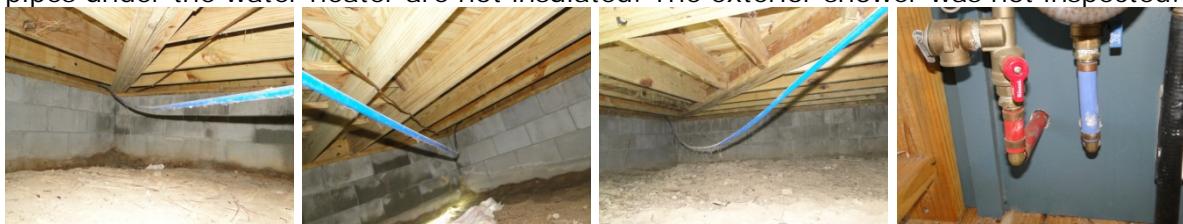
- 1). Exposed water pipes in the crawlspace are unsupported and are not insulated. The exposed water pipes under the water heater are not insulated. The exterior shower was not inspected.

Contact a fully qualified licensed plumbing contractor for further evaluation.

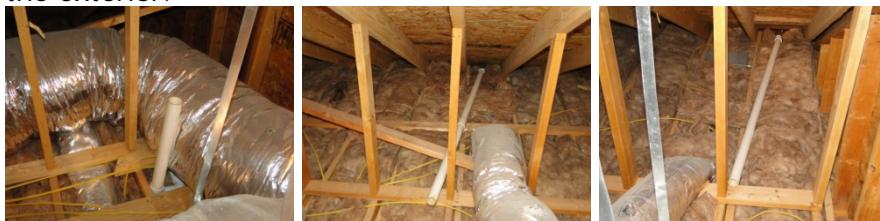
- 1). All of the visible drain ventilation vent pipes terminate on the attic floor instead of directly to the exterior.

Contact a fully qualified licensed plumbing contractor for further evaluation and repairs.

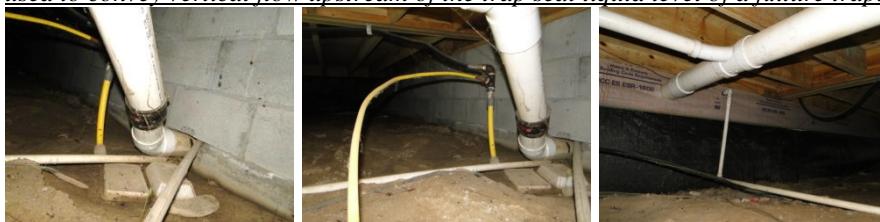
- 2). The drain connection between the sewer pipes in the crawlspace near the right side cleanout is made with a flexible pipe fitting with metal straps. Check the fitting for leaks or obstructions on a regular basis. This type of fitting should not have been needed. **2012 IPC 706.2 Obstructions. The fittings shall not have ledges, shoulders or reductions capable of retarding or obstructing flow in the piping. Threaded drainage pipe fittings shall be of the recessed drainage type. This section shall not be applicable to tubular waste fittings used to convey vertical flow upstream of the trap seal liquid level of a fixture trap.**

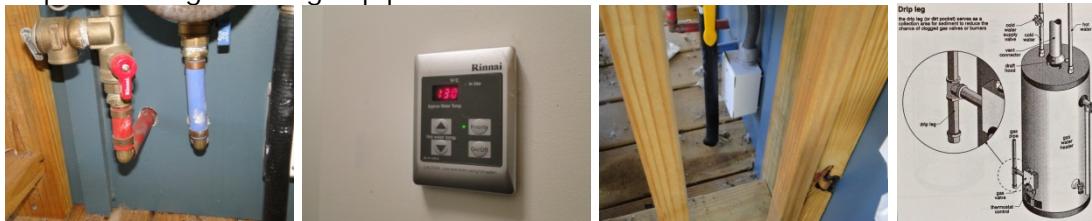
- 1). The hot and cold water pipes under the water heater are not insulated. The temperature of the water is 130 degrees instead of 120. The combustible wood frame installed around the tank is blocking access to service or replace the water heater. Combustible materials are not allowed to be installed near the water heater per manufacture's installation instructions. A sediment trap is missing on the gas pipe near the water heater.

Contact a fully qualified licensed plumbing contractor for further evaluation and repairs. FYI A means of controlling thermal expansion is missing. A backflow device should have been installed near the well holding tank. Follow the manufacturer's maintenance guidelines. Test the TPR valve once a year. The water heater produced very hot water when it was tested. <https://www.rinnai.us/product/tankless-water-heater/r194ep> <https://market.bimsmith.com/file/GetForPreview?id=352156>

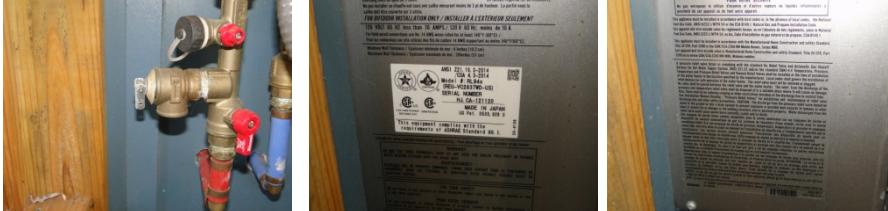
2). A drain pipe is missing on the temperature & pressure relief valve. **2012 IPC 504.6 Requirements for discharge piping.** The discharge piping serving a pressure relief valve, temperature relief valve or combination thereof shall: 1. Not be directly connected to the drainage system. 2. Discharge through an air gap located in the same room as the water heater. 3. Not be smaller than the diameter of the outlet of the valve served and shall discharge full size to the air gap. 4. Serve a single relief device and shall not connect to piping serving any other relief device or equipment. 5. Discharge to the floor, to the pan serving the water heater or storage tank, to a waste receptor or to the outdoors. 6. Discharge in a manner that does not cause personal injury or structural damage. 7. Discharge to a termination point that is readily observable by the building occupants. 8. Not be trapped. 9. Be installed so as to flow by gravity. 10. Not terminate more than 6 inches (152 mm) above the floor or waste receptor. 11. Not have a threaded connection at the end of such piping. 12. Not have valves or tee fittings. 13. Be constructed of those materials listed in Section 605.4 or materials tested, rated and approved for such use in accordance with ASME A112.4.1.

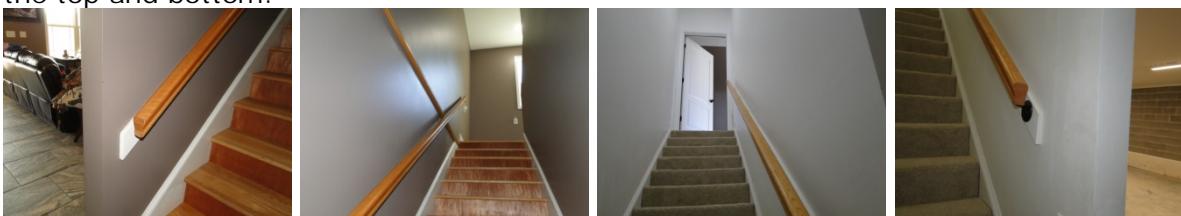
1). The hand railing on the basement and second floor staircases do not turn into the walls at the top and bottom.

Contact a fully qualified licensed contractor for repairs.

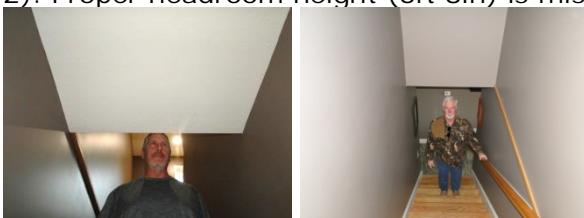
2). Proper headroom height (6ft 8in) is missing on the second floor staircase.

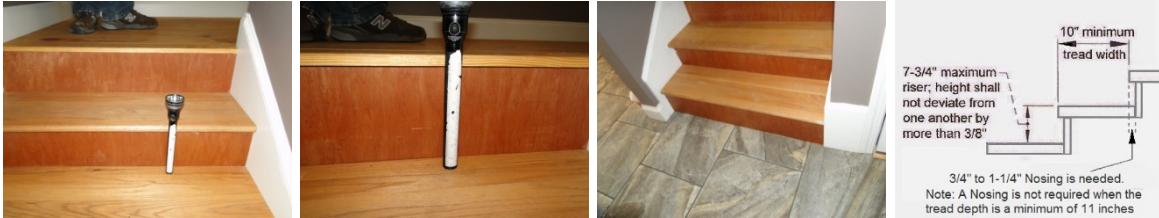
3). The steps risers are uneven on both of the staircases. **2012 IRC R311.7.5.1 Risers.** The maximum riser height shall be $7\frac{3}{4}$ inches (196 mm). The riser shall be measured vertically between leading edges of the adjacent treads. The greatest riser height within any flight of stairs shall not exceed the smallest by more than $\frac{3}{8}$ inch (9.5 mm). Risers shall be vertical or sloped from the underside of the nosing of the tread above at an angle not more than 30 degrees (0.51 rad) from the vertical. Open risers are permitted provided that the opening between treads does not permit the passage of a 4-inch-diameter (102mm) sphere.

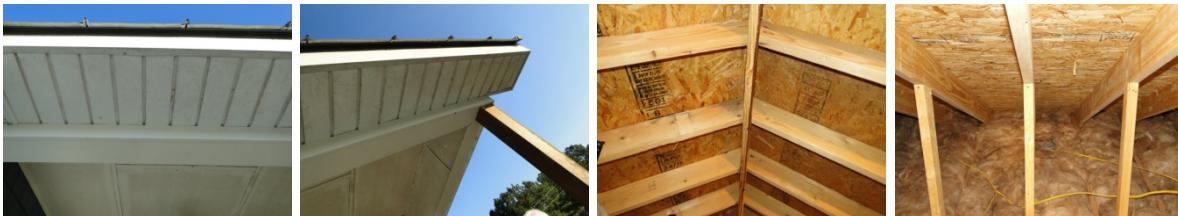
1). Ventilation is missing along the roof overhang and inside the attic. The roofing felt paper is blocking airflow under the metal roof's ridge vent. **2012 IRC R806.1 Ventilation required.** Enclosed *attics* and enclosed rafter spaces formed where ceilings are applied directly to the underside of roof rafters shall have cross ventilation for each separate space by ventilating openings protected against the entrance of rain or snow. Ventilation openings shall have a least dimension of $1/16$ inch (1.6 mm) minimum and $1/4$ inch (6.4 mm) maximum. Ventilation openings having a least dimension larger than $1/4$ inch (6.4 mm) shall be provided with corrosion-resistant wire cloth screening, hardware cloth, or similar material with openings having a least dimension of $1/16$ inch (1.6 mm) minimum and $1/4$ inch (6.4 mm) maximum. point of the space, measured vertically, with the balance of the required ventilation provided by eave or cornice vents. Where the location of wall or roof framing members conflicts with the installation of upper ventilators, installation more than 3 feet (914mm) below the ridge or highest point of the space shall be permitted. **R806.3 Vent and insulation clearance.** Where eave or cornice vents are installed, insulation shall not block the free flow of air. A minimum of a 1-inch (25 mm) space shall be provided between the insulation and the roof sheathing and at the location of the vent.

Contact a fully qualified licensed contractor for repairs. The attic insulation is batt fiberglass.

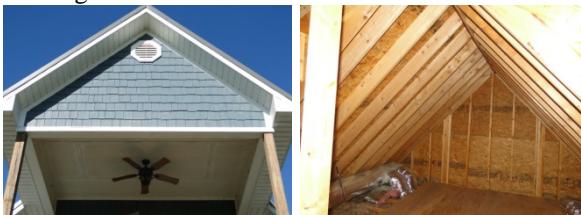
2). Access is missing to enter the attic above the master bedroom's front deck/porch. **2012 IRC 807.1 Attic access.** Buildings with combustible ceiling or roof construction shall have an *attic* access opening to *attic* areas that exceed 30 square feet (2.8 m²) and have a vertical height of 30 inches (762 mm) or greater. The vertical height shall be measured from the top of the ceiling framing members to the underside of the roof framing members. The rough-framed opening shall not be less than 22 inches by 30 inches (559 mm by 762 mm) and shall be located in a hallway or other readily accessible location. When located in a wall, the opening shall be a minimum of 22 inches wide by 30 inches high (559 mm wide by 762 mm high). When the access is located in a ceiling, minimum unobstructed headroom in the *attic* space shall be 30 inches (762 mm) at some point above the access measured vertically from the bottom of ceiling framing members. See Section M1305.1.3 for access requirements where mechanical *equipment* is located in *attics*.

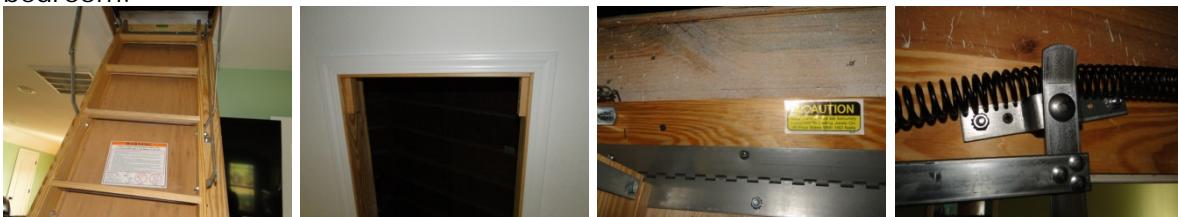
3). The attic ladder is not installed in accordance with the manufacturer's caution and warning labels on the ladder. The ladder is secured using screws instead of 16d common nails. The ladder is not insulated or sealed with weather-stripping. The ladder is installed inside the master bedroom.
